Manhole Inspection Summary

Manhole # S65G__014MH

Insp Date: **3/14/08 9:55 AM**

Location Address: **428 El Rino St.**

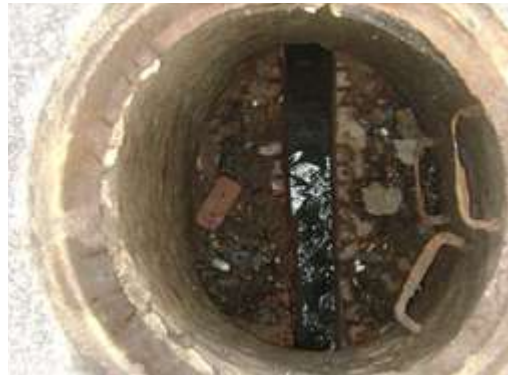
Top View

Cover Shape: **Circular** Diameter: **24** (in.) Length: (in.) Dist A/B Grade: **0** (in.)

Type: **Sanitary** Condition: **Worn** Cover Material: **Cast Iron**

Chimney / Frame Adjustment ☒ Exists Material: **Brick** ☐ Parged Height: **6** (in.)

Condition: ☐ Sound ☐ Cracked ☐ Root Intrusion ☒ **Loose Brick** ☒ **Deteriorated**

Infiltration: ☐ None ☒ **Joint** ☐ Cracks ☒ **Mortar** ☐ Roots ☐ Wall

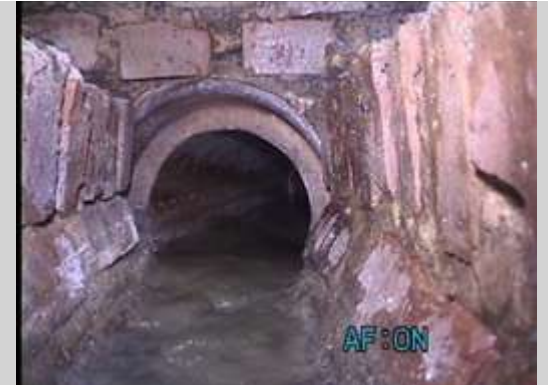
12 O'Clock Outflow

8 in. Circular Gravity Sewer
Pipe Out @ 12 O'Clock

Pipe Height: **8.4** (in.) Rod and Bar (Angled)
Pipe Material: **Clay** ☐ Pipe Lined
Invert Depth: **7.58** (ft.) Flow Characteristics: **Fast**
Deposits: ☒ None ☐ Mud ☐ Sludge ☐ Debris ☐ Grease
Silt Depth: (in.) Deposits Extent:
Infiltration: **None** Pipe Seal Cond: **Sound**
